EXAMPLE IMAGES POS MONITORING DURING LASER WELDING

Movement of the mean values and behavior of the measured values Troubleshooting

- Welding of circumferential welds
 - for connecting nested tubes
- CO2 Laser
- 6kW maximum laser power
- 12 tack welds
- 12 seams with about 20-30s length

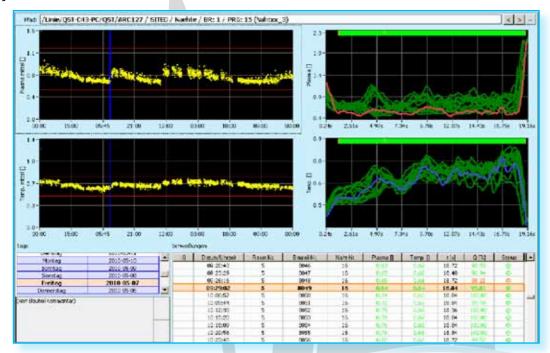
Drift of the mean values and abrupt change after maintenance work (5 days)

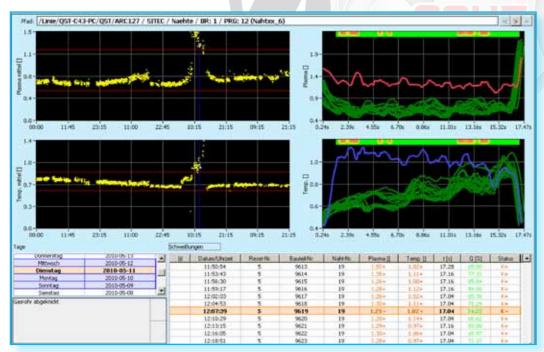
Gas interference by bruised inert gas pipe (Fault occurred in serial production)

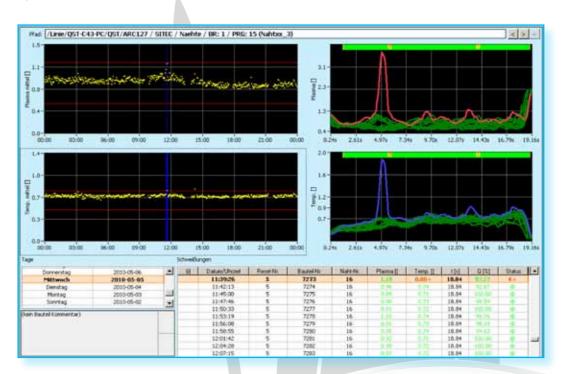
probably selective weld defects

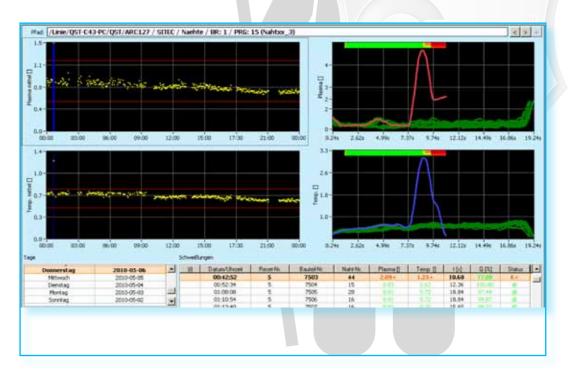
weld Stop

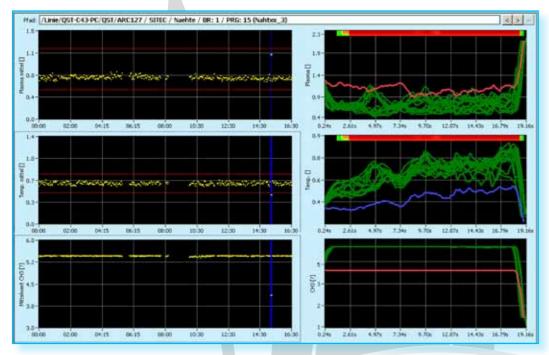
Weld Stop attempt to interfere laser power (Ch3) with seam 3 of 93% reduced to 70%

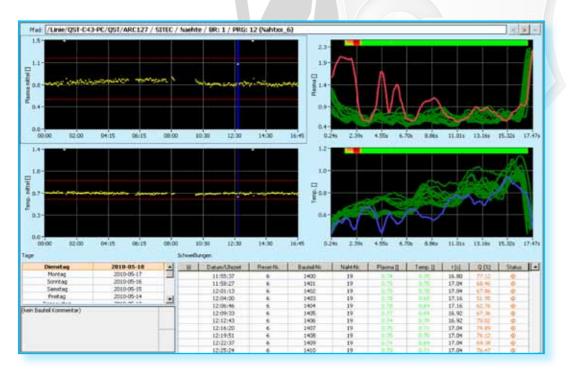
Attempt to interfere sticker between the pipes with seam 6

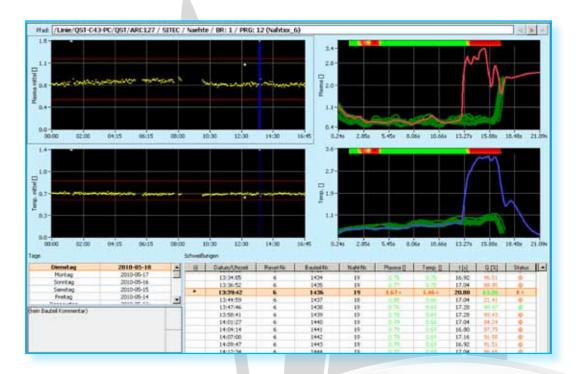
probably burn out at the end of the seam weld 6

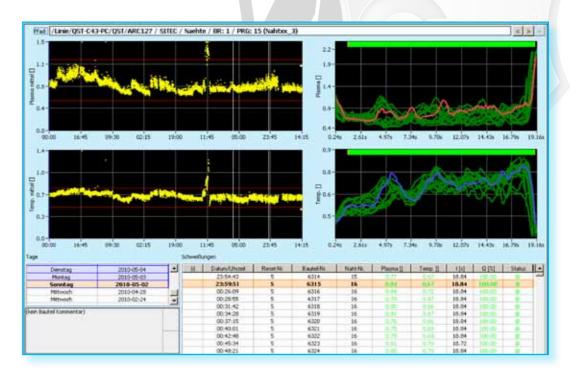
Long time response (over 16 days) (gas interference can be seen as well)
